Phase I- Complete: Plan Design, Compliance and Baseline Monitoring

Phase II: Construction (See Appendix 1 for figures and photos)

Summary of Work Completed

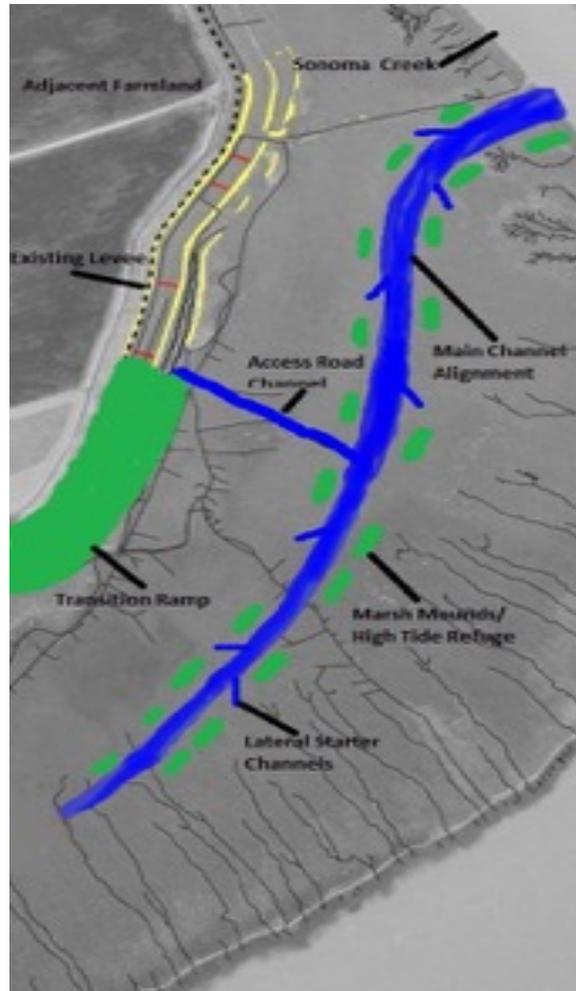
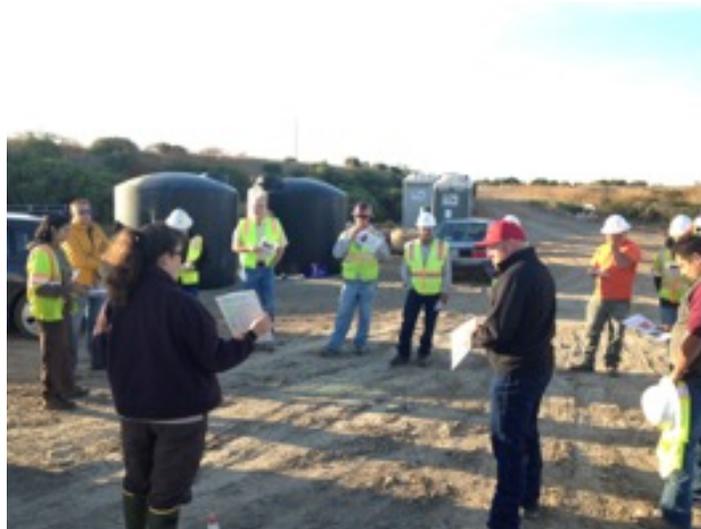
Figure 1. This drawing represents the completed work on the Sonoma Creek Enhancement Project as of 11/30/30/2015. This image is not drawn to scale. Blue aspects represent the main channel alignment, access road channel, and lateral starter channels that now allow natural tidal fluxuation and drain water off of the once inundated marsh. Green aspects represent high tide refuge in the form of 22 marsh mounds on the marsh and approximately 9 acres of transition ramp (only part of which is shown on the figure below) placed on the marsh from material excavated from the main channel. These elements provide habitat for wildlife in high tide and flood events and are precedential in sea level rise habitat resiliency.

By October 30th Hanford had excavated the southern half of the channel over 2,300ft from the channel southern endpoint to channel midpoint (Figure 1), excavating and transporting material simultaneously as access road material was removed. Before excavating the northern segment of the channel from Sonoma Creek back to the midpoint, a turbidity curtain was installed to catch free floating sediment and discourage entrance of marine wildlife. In 3 days, Hanford excavated the channel mouth 50ft wide to a depth of -1 NAVD88 and installed a 10,000 gallon temporary Aquadam to inhibit wildlife access to the construction site. 1/32 inch mesh screen was installed over preexisting channels connected to the construction site to prohibit the entrance of fish and marine wildlife into the construction site. The remaining 2,260ft of main channel alignment was excavated and material was placed in high tide refuge (i.e. marsh mounds and transition ramp). After the main channel excavation was complete, and northern and southern sections joined, Hanford precut a small channel to drain the access road depression, and removed the Aquadam and turbidity curtain from the channel mouth to reinstall it at the access road connection channel point to discourage wildlife entrance while the access road channel was being excavated. All mesh screens and wildlife prohibiting material were removed by 11/30/2015, and wildlife now have full access to the main channel alignment.

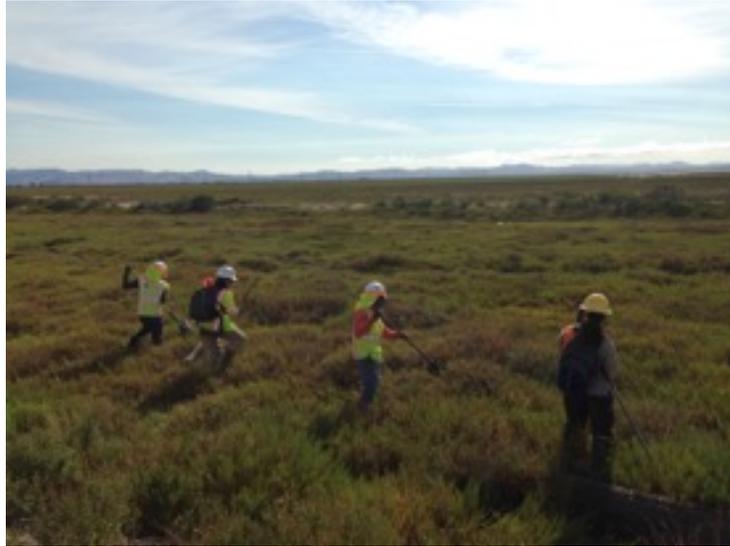
Figure 3. After being trained in marsh flushing techniques for wildlife protection, the Hanford team flushed the marsh just ahead of the clearance crew which removed vegetation. This ensured that species of concern did not return to the work area as the access road was built and machinery brought in for channel construction.

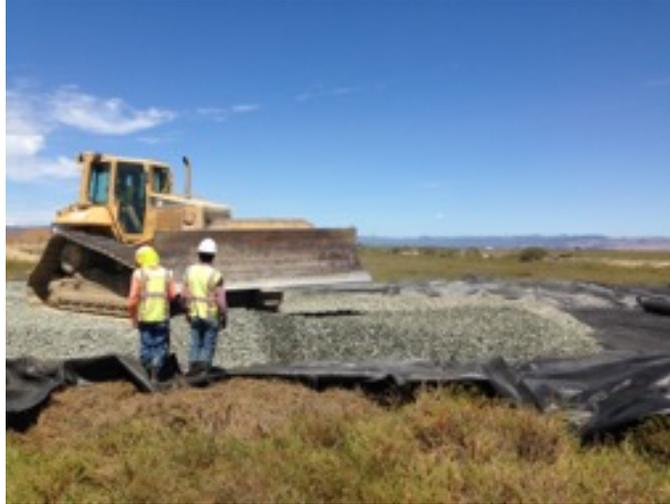
Figure 4. Over 14,000 tons of drain rock was brought into the staging area by Hanford for construction of the permeable “floating” road that is used to access and excavate the channel alignment.

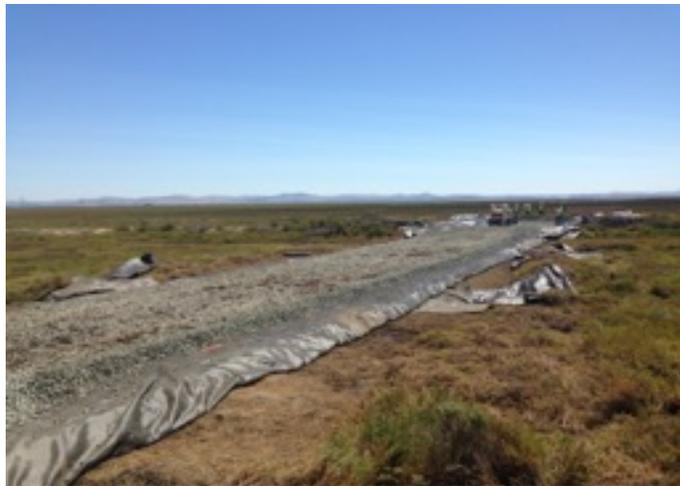
Figure 5. Hanford designed and constructed a 18"-24" thick, permeable access road from adjacent farmland levee to the center of the marsh and Sonoma Creek Enhancement Project Area. All road material was removed simultaneously with Hanford's excavation of the main channel.

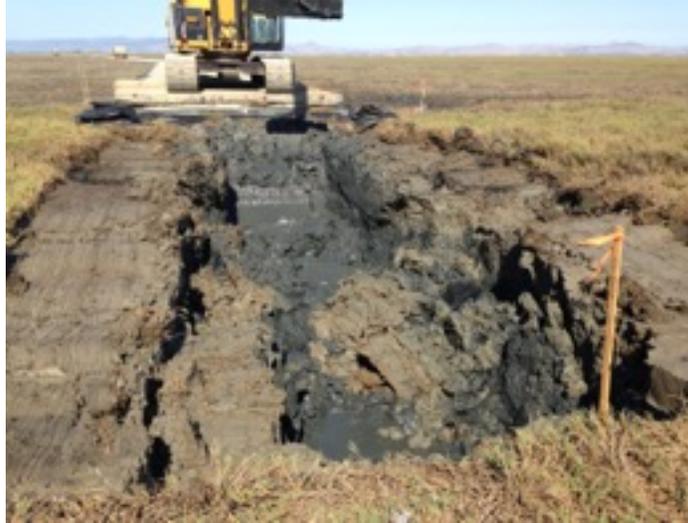
Figure 6. Once the access road was laid, Hanford continued the road south towards the endpoint of the main channel. When completed, the access road to and along the main channel alignment reached just under 1 mile in length.

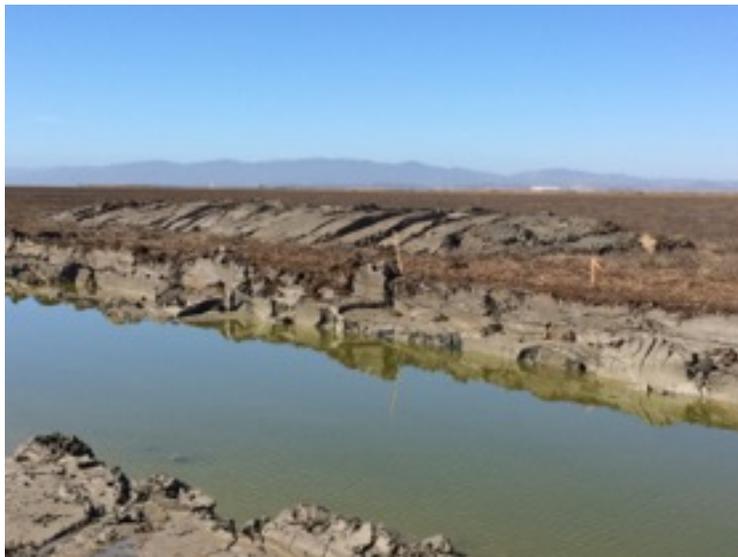
Figure 7. Hanford excavated the southern end of the main channel alignment with an approximately 16ft top width and 5ft depth. The channel top width gradually widens as the channel nears Sonoma Creek to 50 ft top width and 7.5ft depth from marsh elevation. Because of difficult construction conditions and substrate consistency, the side slopes were modified from a 1:1 to a 3:1 slope ratio to ensure channel banks do not slump more than expected.

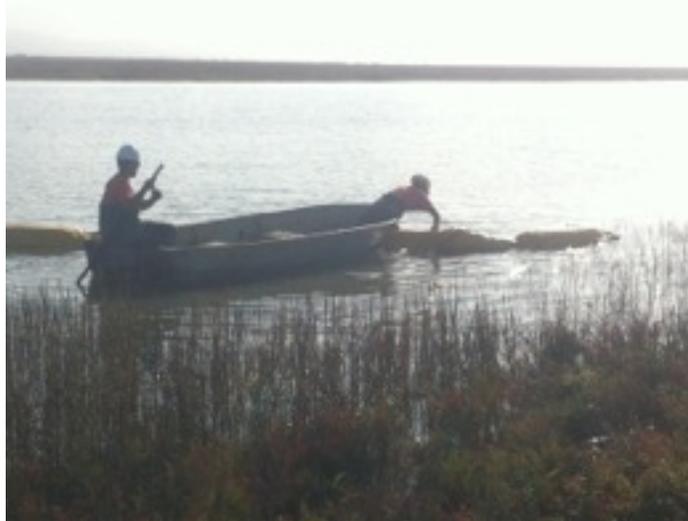
Figure 8. 22 marsh mounds have been built from the soil material excavated from the channel. Marsh mounds will offer high tide refuge for marsh wildlife adjacent to the channel alignment.

This is one of Sonoma Creek Enhancement Projects climate change habitat resiliency modifications.

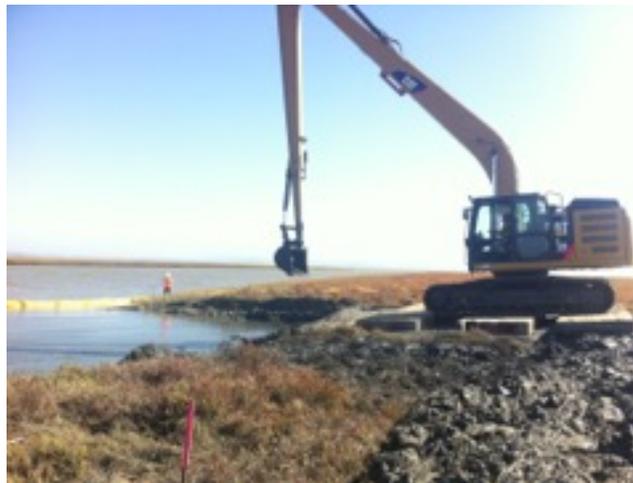
Figure 9. An exclusion curtain was placed to inhibit the access of marine wildlife such as fish and mammals into the construction zone and stop suspended sediment from entering Sonoma Creek and San Francisco Bay.

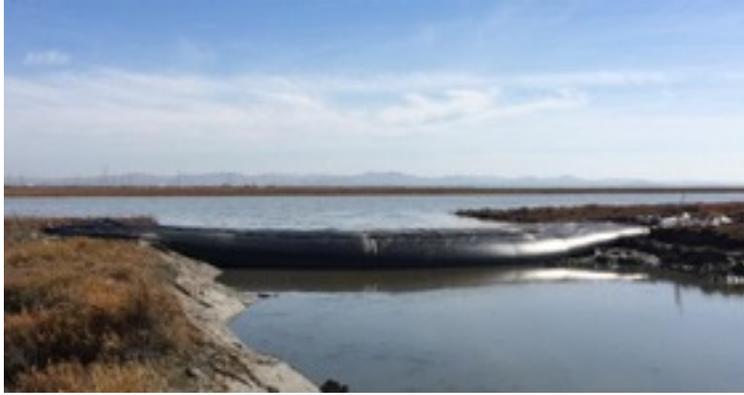
Figure 10. At its widest point, the channel mouth connection point at Sonoma Creek, the channel alignment reaches over 50ft top width and is 7-7.5 ft deeper than marsh elevation.
